30m QRSS beacon: QRV: Another round of reports

Written by Hans Summers
Monday, 25 May 2009 02:57 -

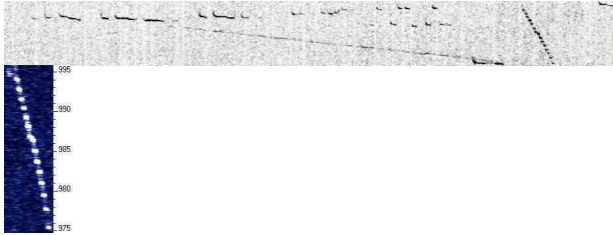
This one from Heinz OE5EEP, 01-Apr-04 17:30 is on the same timescale as yesterday's, and shows that unfortunately the frequency instability (chirp) on key-down is still there, despite all my efforts with the power supply, buffers and so on! Another problem is that the staircase shows a discontinuity between step 7 and step 8, which are almost at the same height (I think this has always been a problem, see earlier screenshots). On the plus side, it does show that the staircase height has been successfully reduced back to 20Hz.
