30m QRSS beacon: QRV: even more changes

Written by Hans Summers
Monday, 25 May 2009 03:02 -

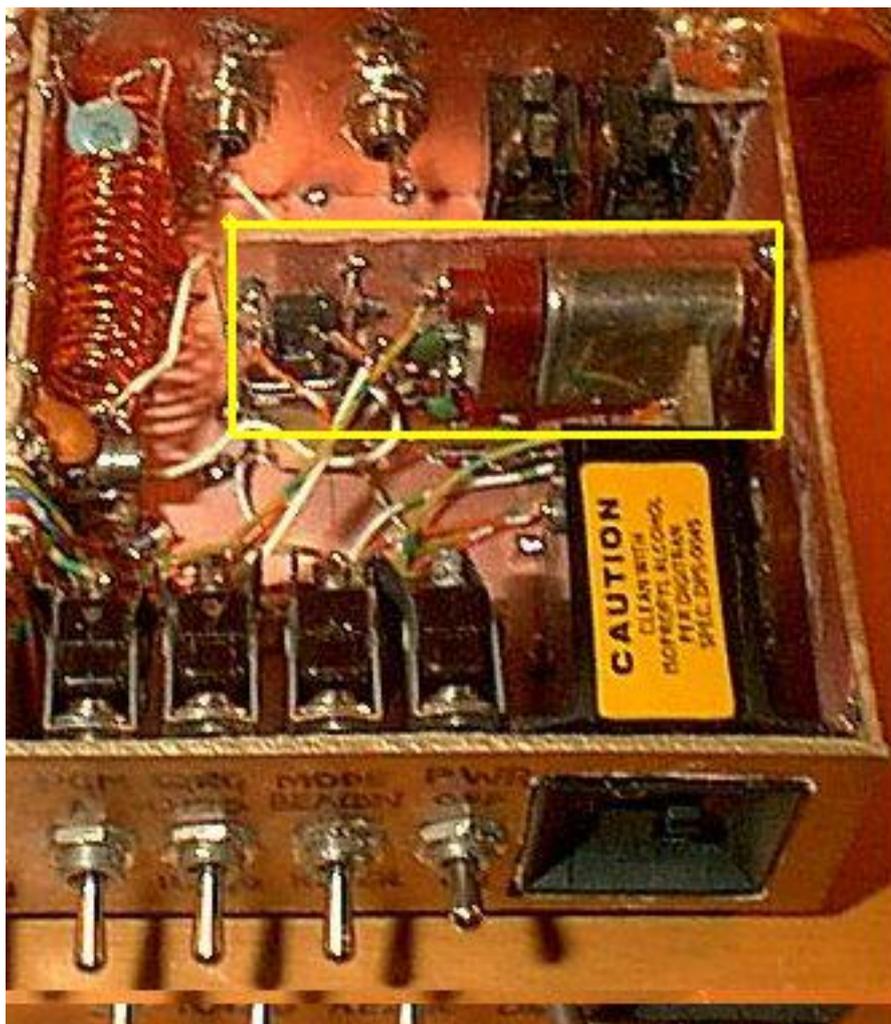
Yet one more attempt to remove the troublesome chirp and stabilise the frequency! Since the oscillator chip was right next to the output pi-network I decided to try moving it further away, and putting it in a screened box made from single-sided PCB stock. The picture shows the oscillator board, before and after. Screened cable takes the oscillator output to the pa, and brings in the frequency control voltage.

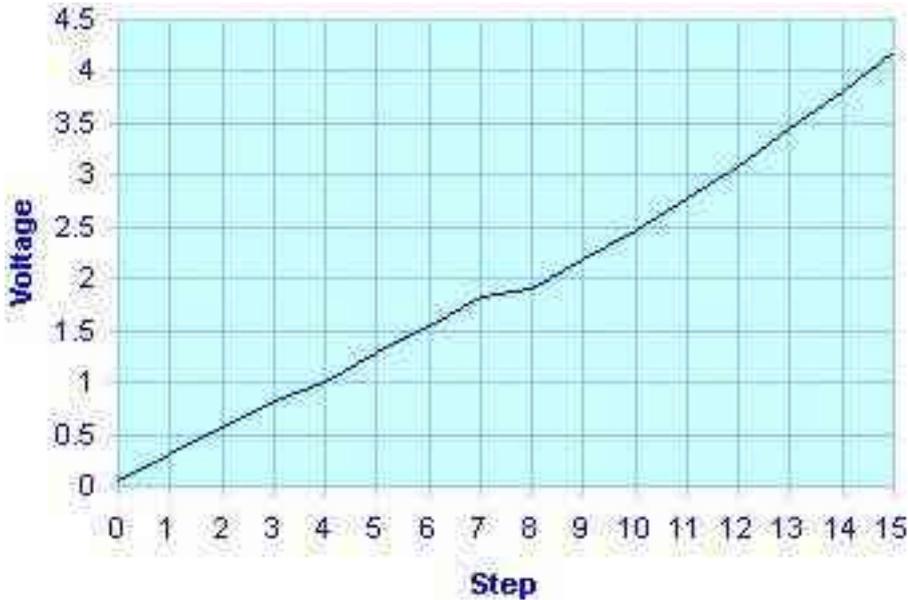
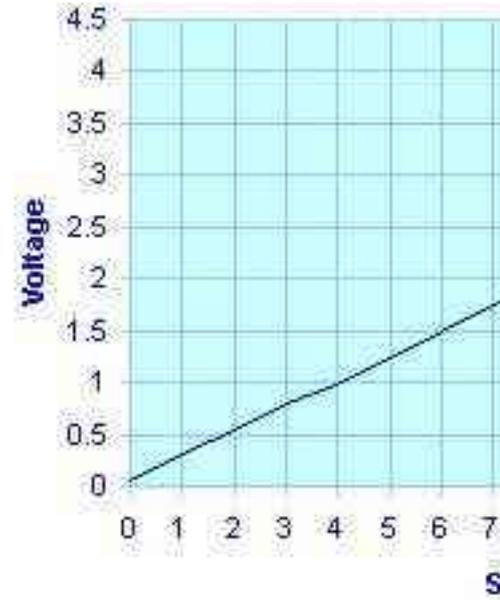
I ended up with 3 parallel resistors to the 10K resistor: values 220K, 470K and 560K. The combined value of the added parallel resistance is therefore 118K. The chart below shows the measured voltage before (left) and after (right) the corrective resistors were added. You can see that the problem with the curve at step 7 - 8 is gone. The line still isn't completely perfectly straight now I have measured it in detail, but it will be good enough to remove the observed discontinuity on the screenshots.

Next, I attempted to linearise the frequency shift (see the same-frequency 7'th and 8'th steps on the screenshots above). The lack of shift occurs when the shift changes from step 7 to 8. Therefore it is due to the 10K resistor in the resistor network being slightly off-value.

To correct the abnormality I experimented with several different value resistors in parallel with it (not being able to find easily a sufficiently high-valued preset potentiometer in the junk box). The

voltage at the output of the resistor network was measured to 2 decimal places on my DVM (at the junction of the 10K, 20K, 40K and 80K resistors).
